**TOWN OF TRUMBULL
SANITARY SEWER SYSTEM REVIEW
PHASE 4, PART B, CONTRACT III (JOG HILL AREA)**

March 15, 2011

FINAL

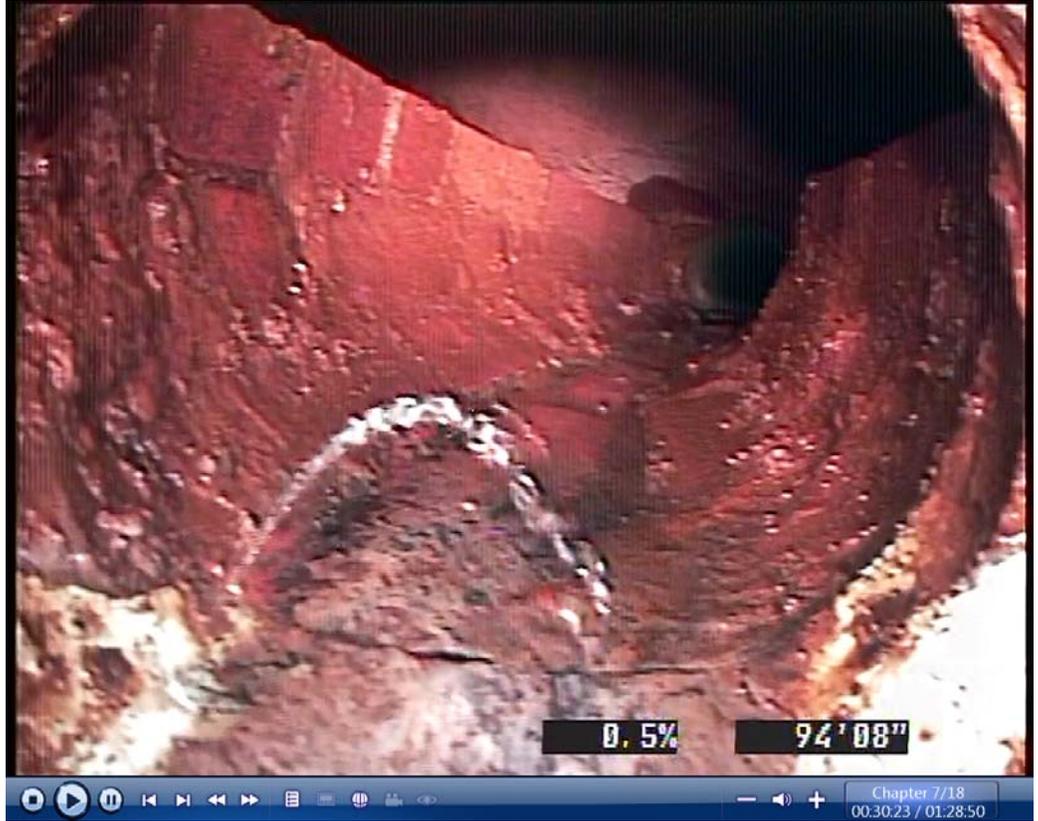
Booth Hill Road
BO-7 to BO-6

Groundwater
Infiltration at
Manhole Interface

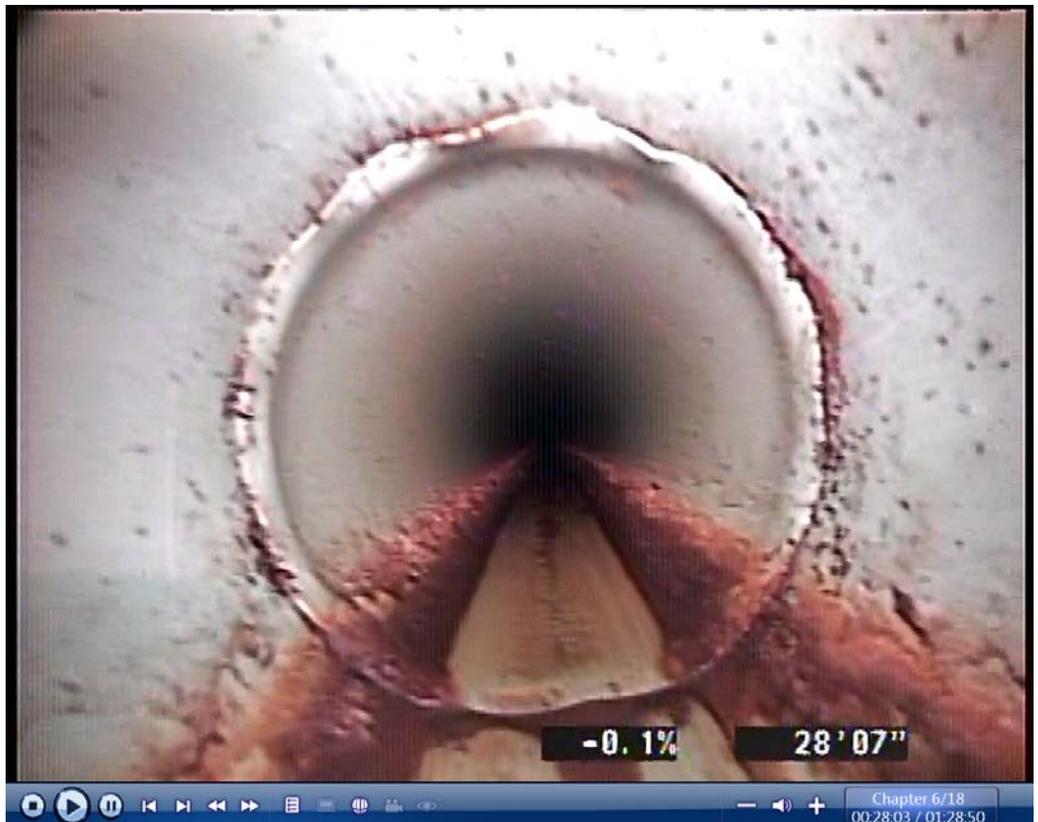
Booth Hill Road
BO-5 to BO-6

Overbelled

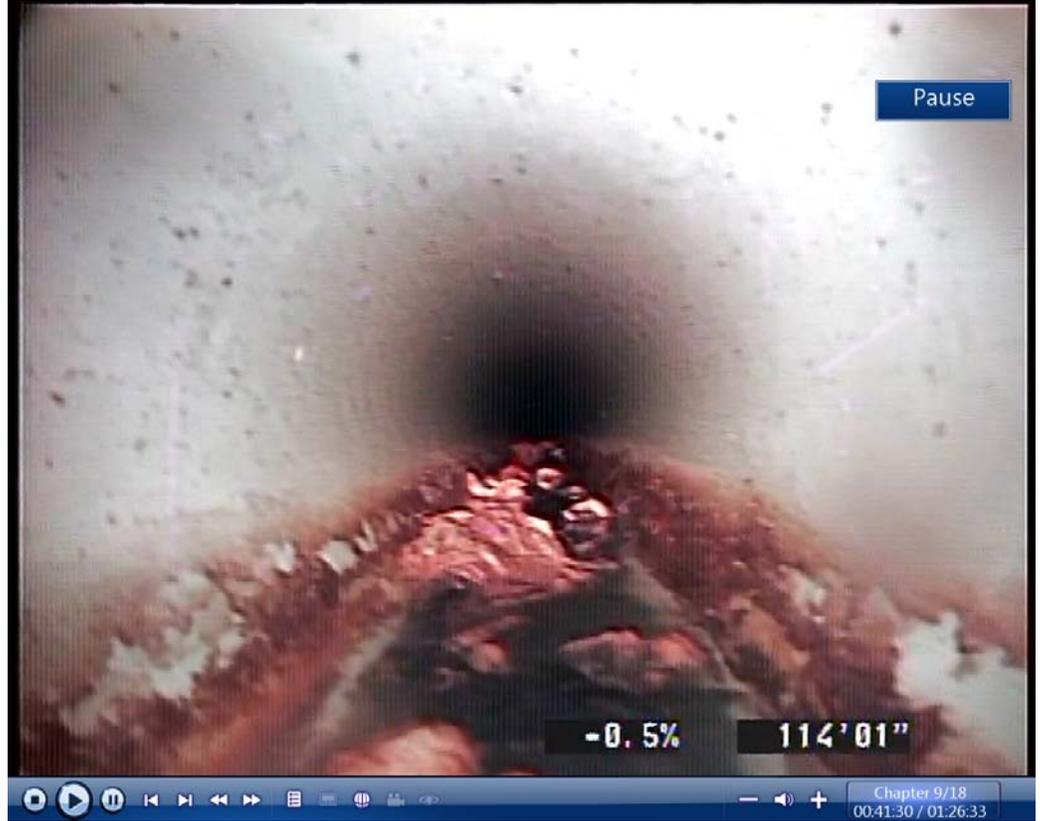
Booth Hill Road
BO-16 to BO-15

Sag with Debris
Buildup

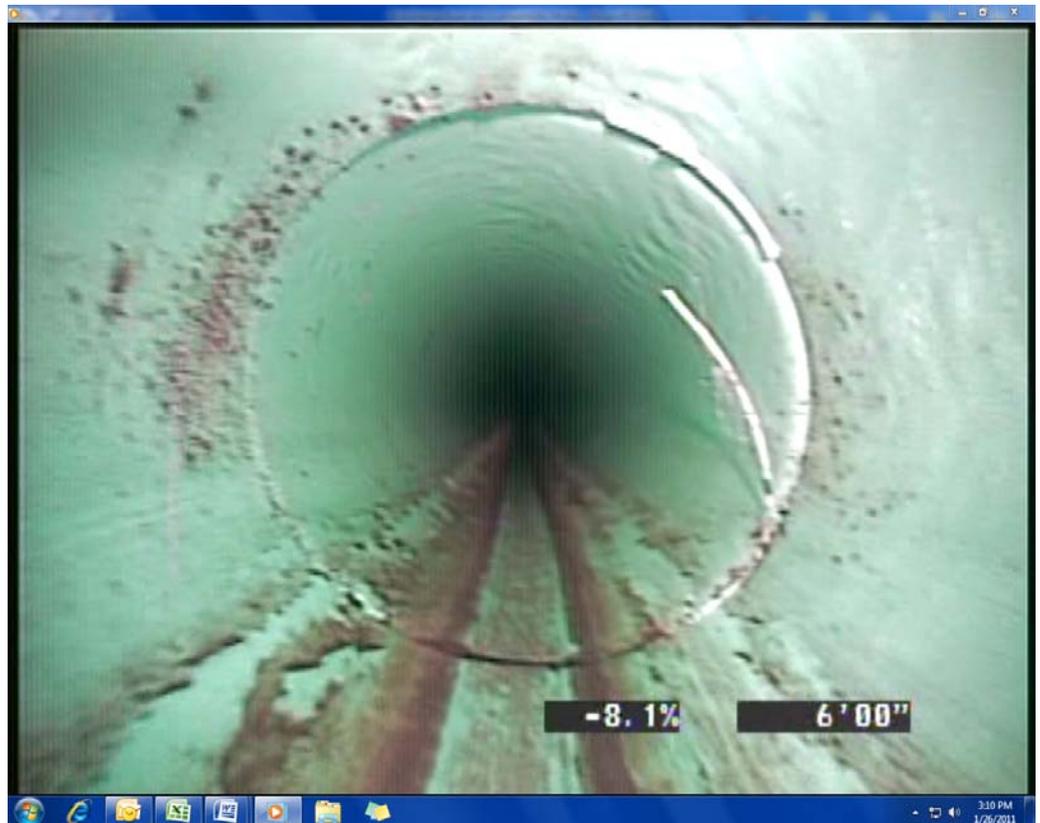
Brookhedge Road
BH-4 to BH-5

PVC Fragment in
Joint

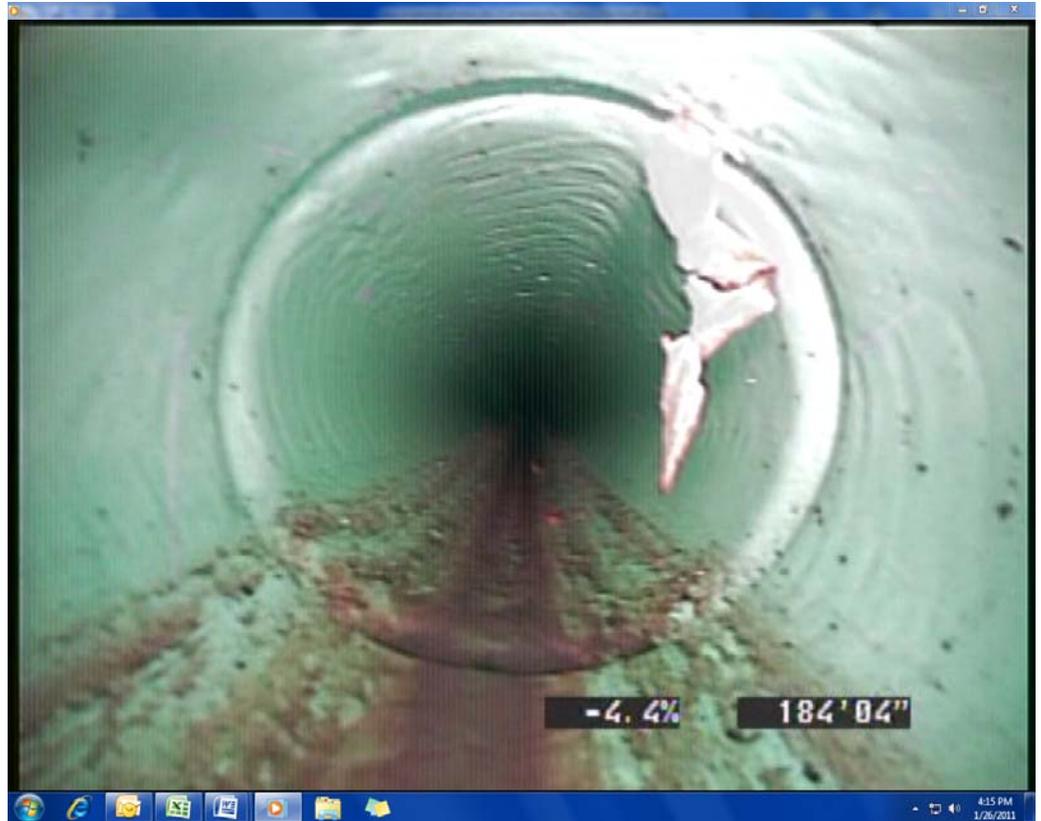
CU-5 to CU-6

Debris in Joint

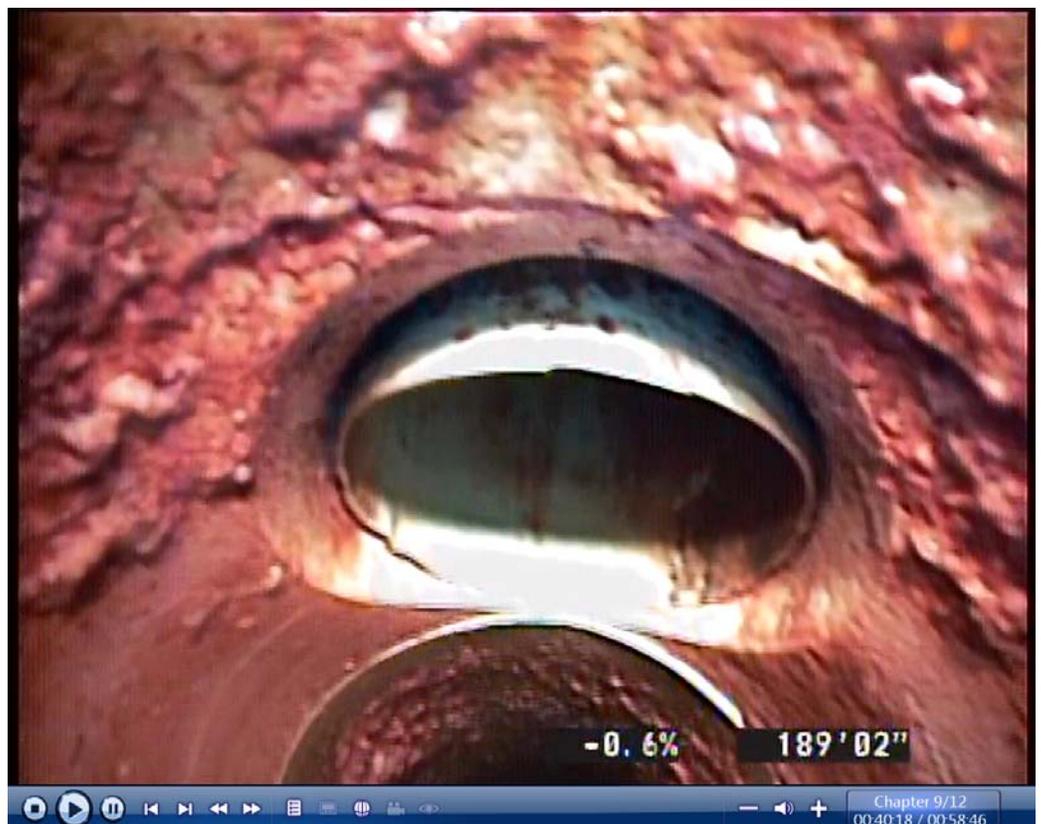
HU-6 to HU-5

Pipe Pushed
Through Chimney
Connection

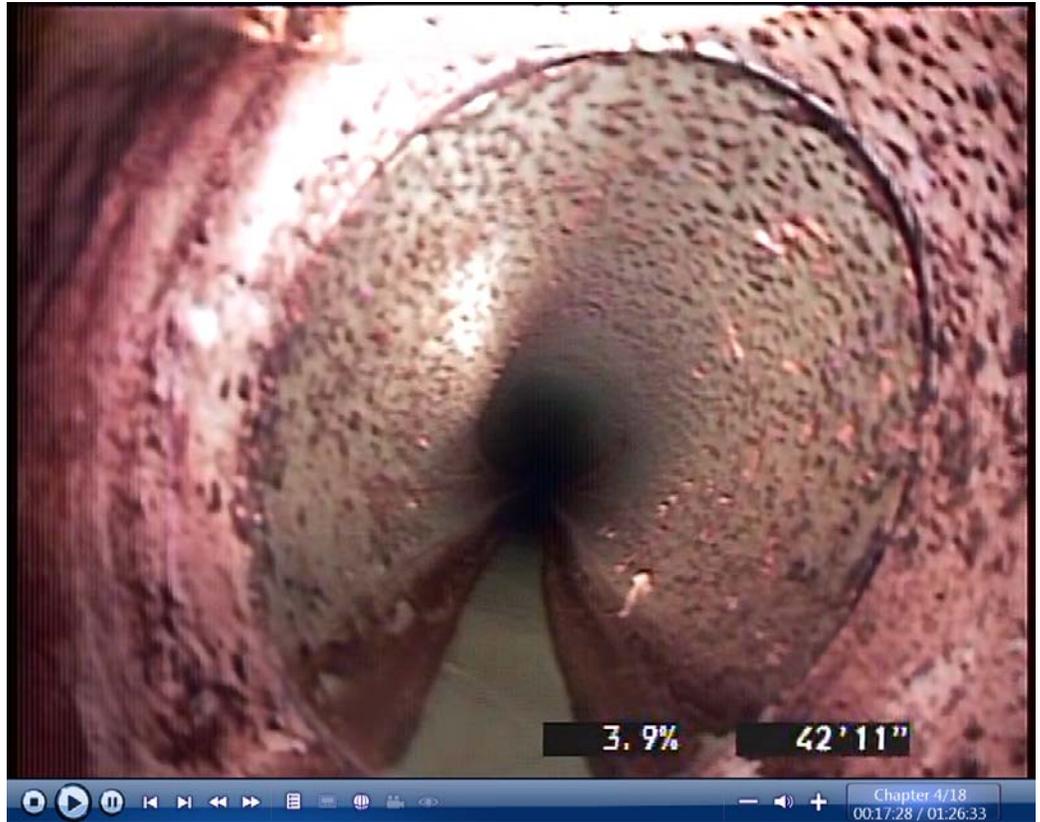
Hurd Road
HU-11 to HU-10

Extremely
Deformed Pipe
(Camera unable to
fit through)

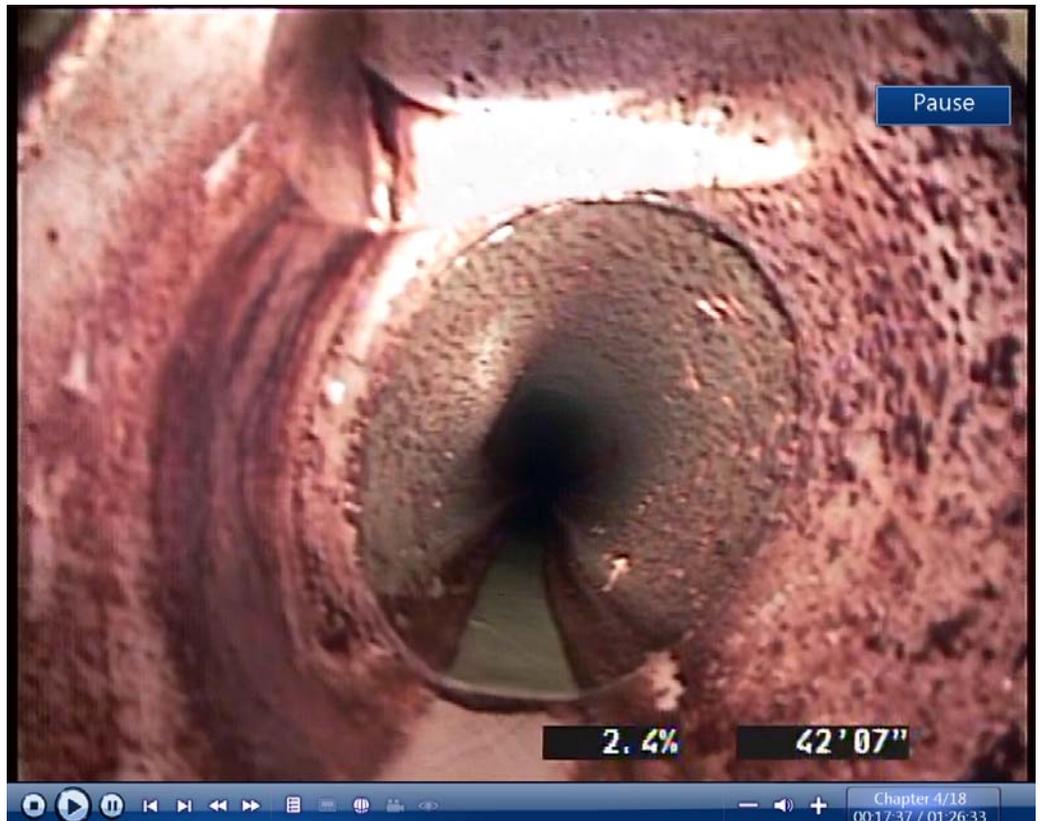
Hurd Road
HU-11 to HU-10

Deformed Pipe
Located Near
Chimney
Connection

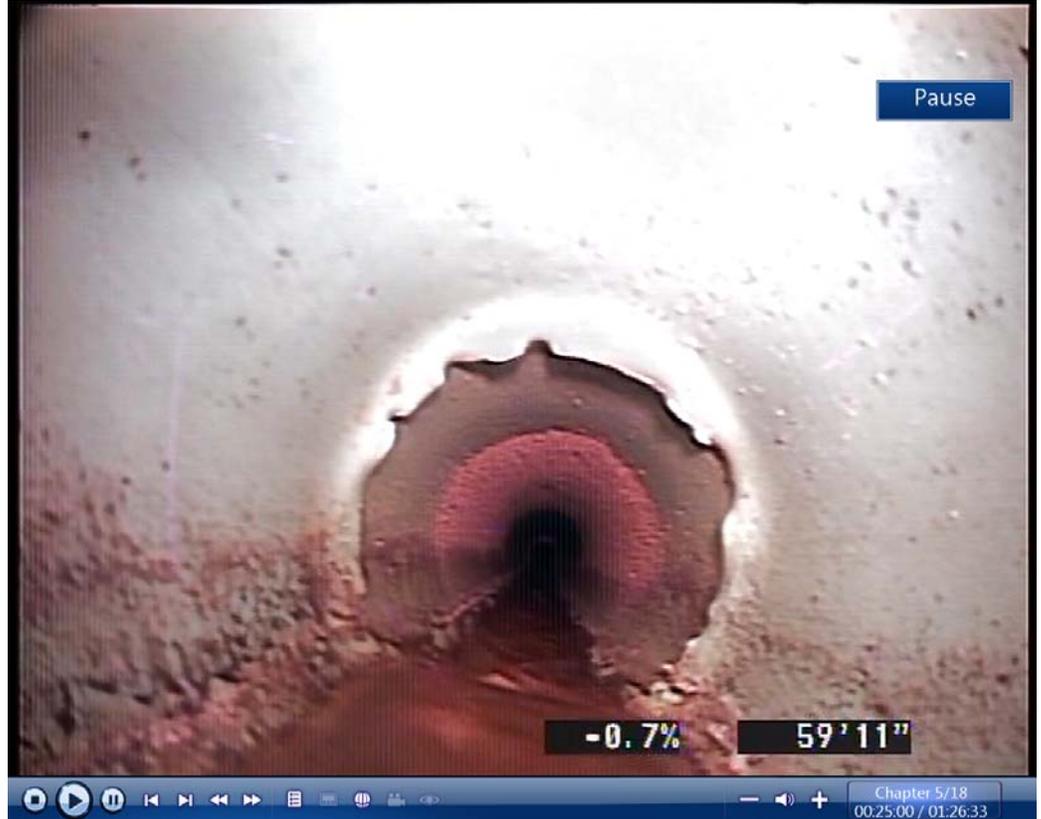
Hurd Road
HU-10 to HU-11

Extremely
Overbelled

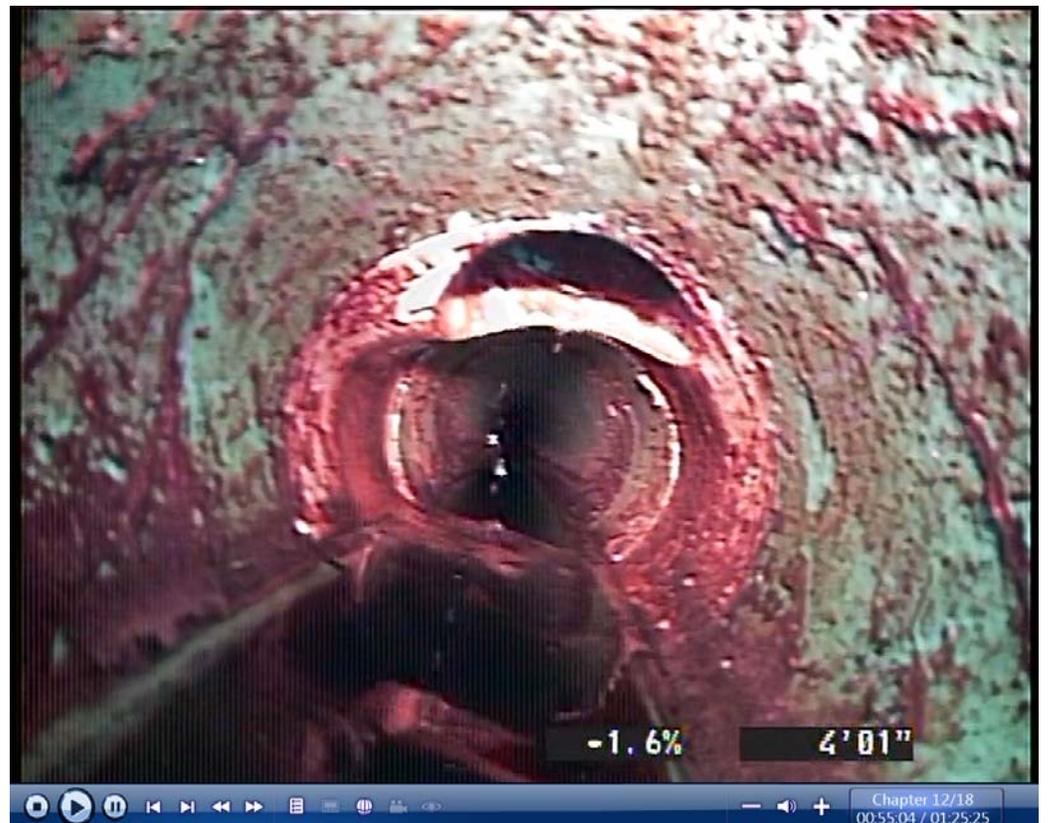
Marathon Road
MR 6A to MR-6

Cracked Saddle
with Groundwater
Infiltration

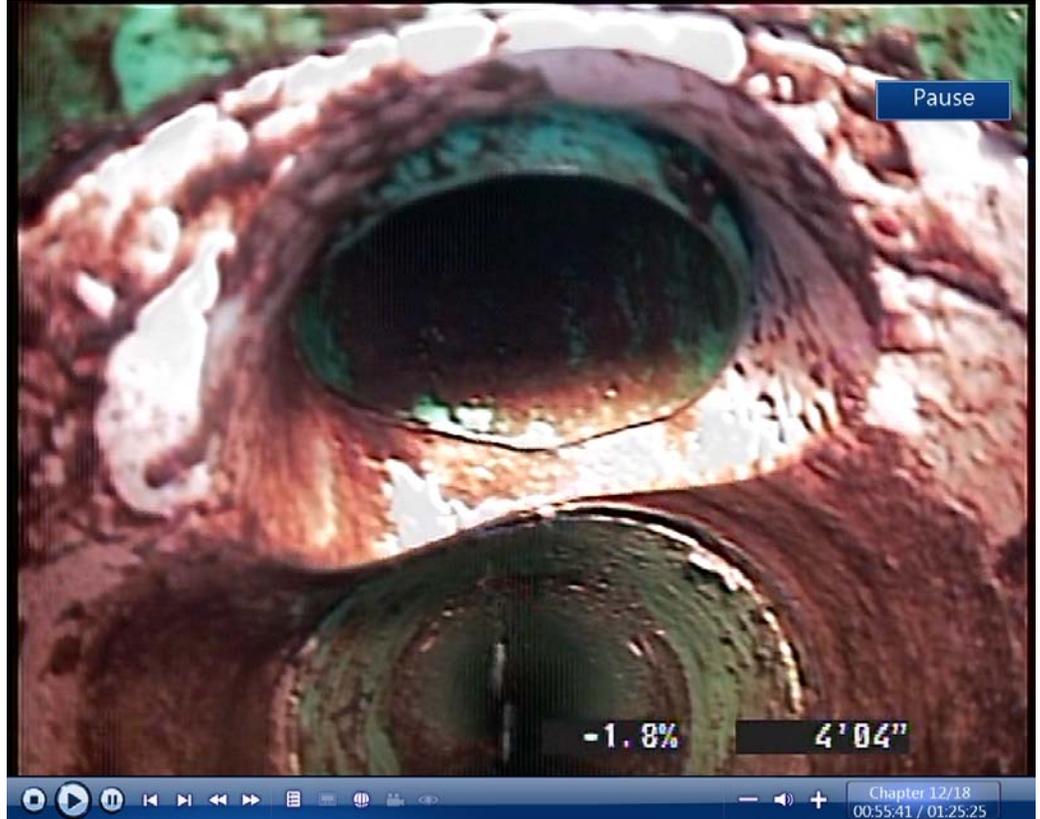
Marathon Road
MR-6A to MR-6

Top View of
Cracked Saddle

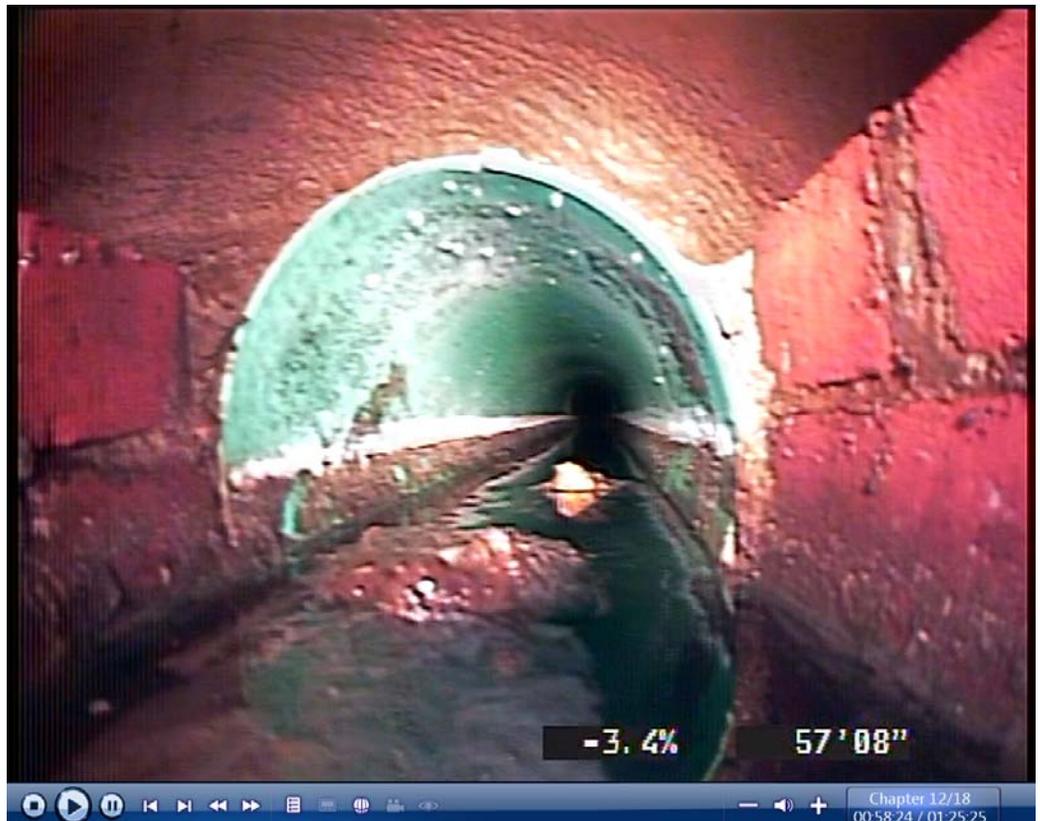
Marathon Road
MR 6A to MR-6

Inflowing Invert at
MH MR-6 is at a
Lower Elevation
than the
Outflowing Pipe

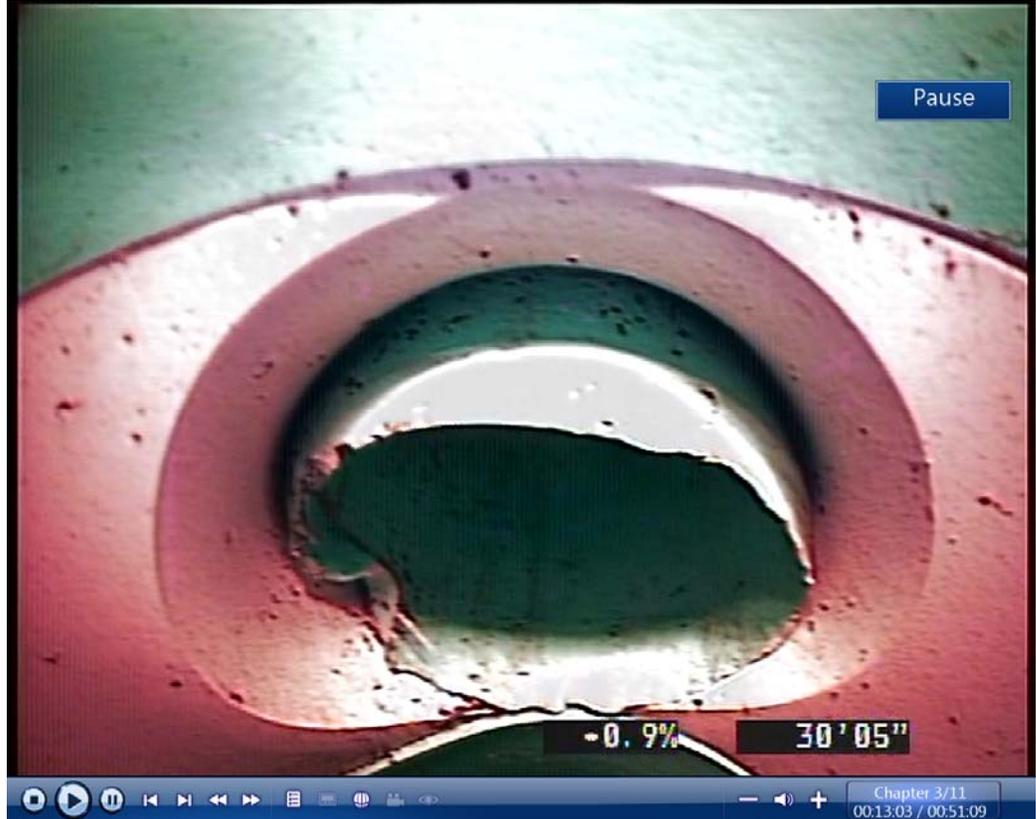
Marathon Road
MR-1 to DF-44

Pipe Pushed
Through Chimney
Connection

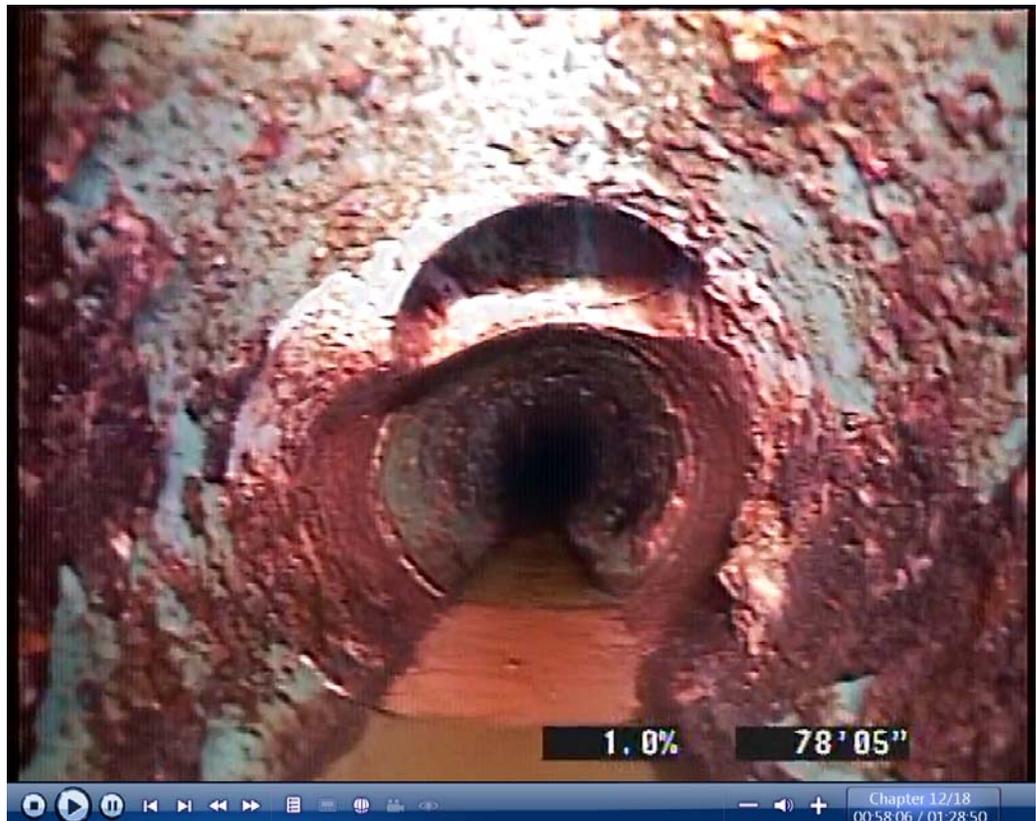
Ranch Drive
RA-1 to HU-12

Chimney Failure

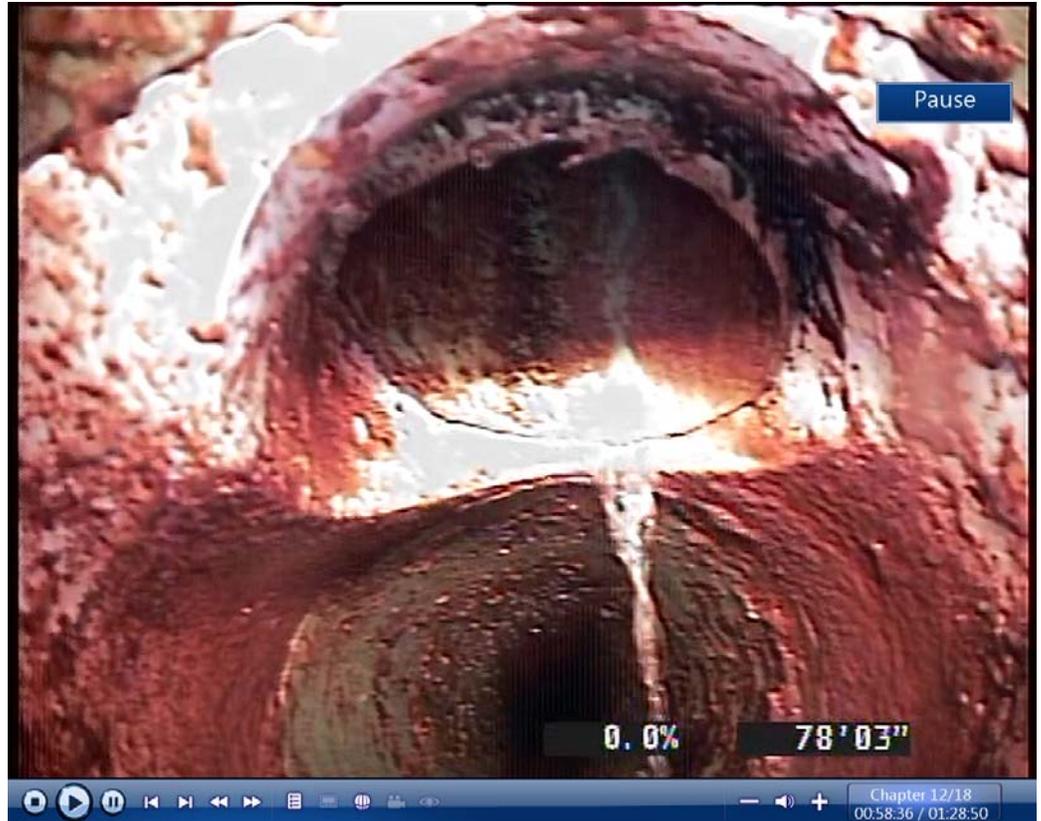
Ranch Drive
RA-1 to HU-12

Pipe Pushed
Through Chimney
Connection with
Groundwater
Infiltration
