Re: 147 Daniels Farm Road- Paugusett Village

SITE MAINTENANCE PLAN

PAUGUSETT VILLAGE
ANALYSIS OF DETENTION BASIN FAILURE

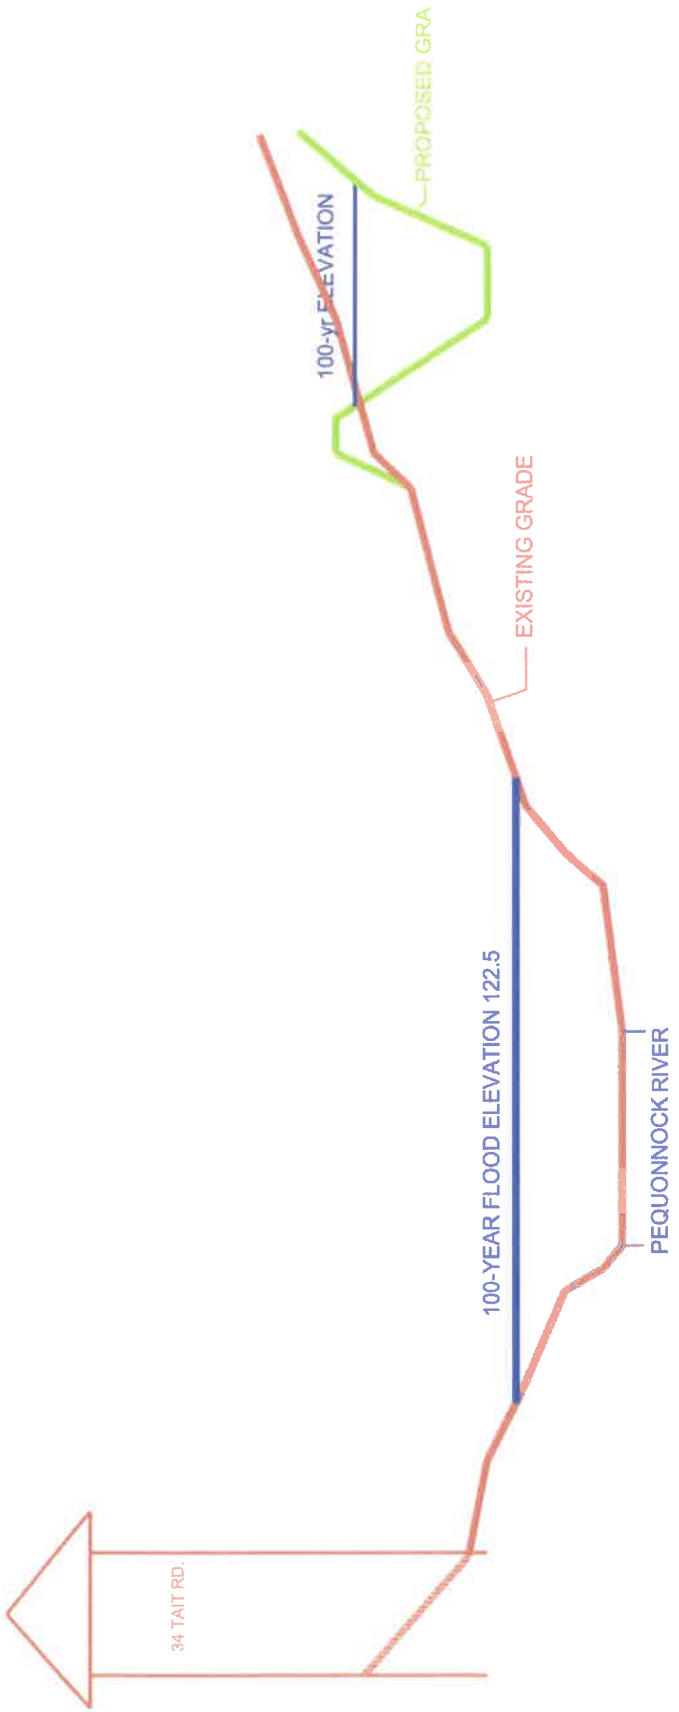
CROSS SECTION

Not with standing the above noted design safe guards, an analysis was made of the effects of a basin failure. An earthen berm failure will occur from by the overtopping of the berm and the erosion of the berm. This will form a V channel in the berm. The V will expand until the bottom of the V reaches the original undisturbed ground level. The attached cross section is drawn through the basin, through a saddle on the downhill side of the basin, to the River. It shows the maximum elevation in the basin during a 100-year storm is 131. The original ground under the berm is at elevation 130. Therefore, the maximum depth of the V channel will be one foot. Because the V will be formed by erosion, the side slopes of the V will be 1 to 1. When the 1-foot deep V channel is fully formed, the velocity through the V will 2.23 feet per second. In one hour, the water level in the basin will be lowered to elevation 130.6 and the velocity through

During a 100-year flood event, the flow in the Pequonnock River at this site will be about 5.5 feet deep with a velocity of 6.9 feet per second and will be carrying about 5810 cubic feet per second. The introduction of 2.23 cubic feet per second with a depth of 0.089 feet and a velocity of 1.98 feet per second will have little to no effect on the flow in the River or impact on adjacent properties.

100-YR FLOOD
ELEVATION
123

SCALE:
1" = 50' HORIZONTAL
1" = 250' VERTICAL

There are several design factors used in the design of the detention basin that will negate to the possibility of the failure. The first of these is the depth of the berm which will impound the storm water. The maximum elevation of the storm water in the basin during a 100-year storm is 131.0. The existing ground under the berm ranges from elevation 132 to 127. There is about 100 feet where the depth from existing ground to the flood level in the basin is four feet. The average depth is two feet.
